Inventory #6C-CM02 22' x 38' Unused Metso 10 MW Ball Mill

UNUSED METSO 22' x 38' (6.7m x 11.6m)Ball Mill, 10,000 kW (13,410 HP) Twin Pinion 50 Hz Teco Motors and Gear Reducers

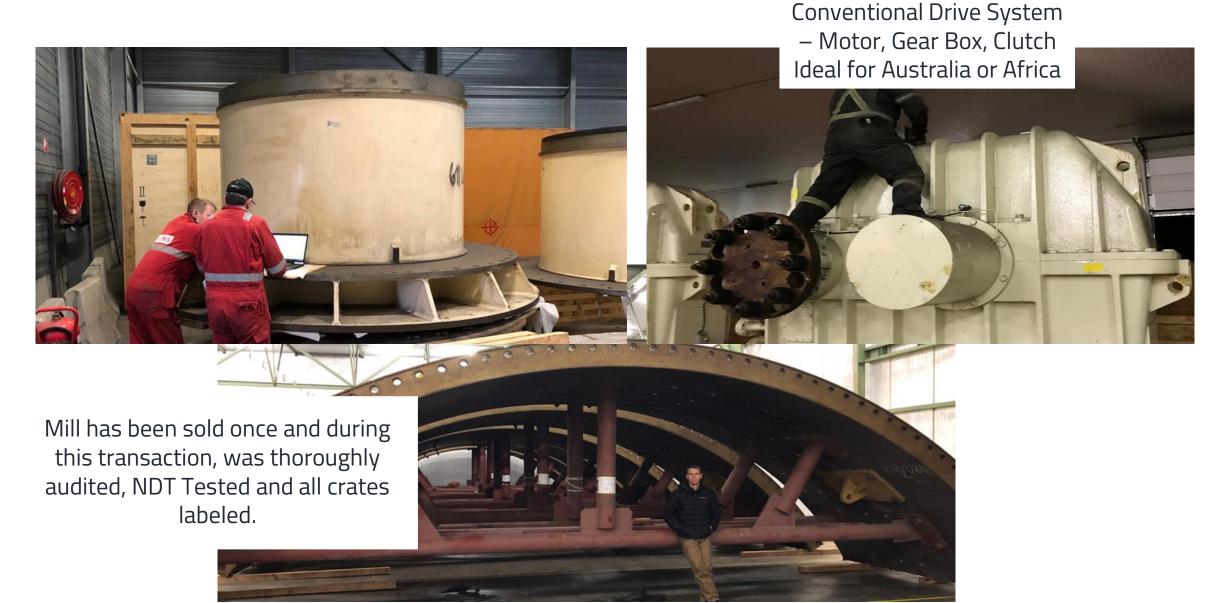
OEM Inspection Process – our goal is that a surplus mill based on inspection is less risky than a new build

PT 100	Heizung - Erde 500 Volt	U1 - Erde 1000 Volt	V1 - Erde 1000 Volt	W1 - Erde 1000 Volt	U - V 1000 Volt	U - W 1000 Volt	V - W 1000 Volt	Läufer - Erde 1000 Volt
Februar 12 19.03.12	114,5 Ώ	250 ΜΩ	20 GΩ	20 GΩ	20 GΩ	30 GΩ	30 GΏ	30 GΩ	2,5 GΩ
Mai 12 13.06.12	116,7 Ώ	200 ΜΏ	20 GΏ	20 GΩ	20 GΩ	30 GΩ	30 GΏ	30 GΩ	3 GΩ
Juli 12 20.07.12	111,8 Ώ	100 ΜΏ	30 GΩ	30 GΩ	30 GΩ	50 GΩ	50 GΩ	50 GΏ	6 GΩ
Oktober 12 25.10.12	116,2 Ώ	200 ΜΩ	30 GΩ	30 GΩ	30 GΩ	50 GΩ	50 GΩ	50 GΏ	4 GΏ
Januar 13 28.01.13	113,3 Ώ	250 ΜΏ	30 GΩ	30 GΩ	30 GΩ	40 GΏ	40 GΩ	40 GΏ	5 GΏ
April 13 25.04.13	115,3 Ώ	200 ΜΩ	30 GΩ	30 GΩ	30 GΩ	40 GΩ	40 GΩ	40 GΩ	4 GΩ
November 13	112,6 Ώ	250 ΜΏ	30 GΩ	17
